Pilot Study to Characterize Ordnance Contamination Within the Sea Bright, New Jersey, Sand Borrow Site

by Joan Pope, Richard Lewis, Andrew Morang, Timothy Welp

Final report

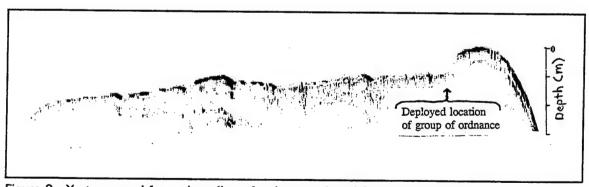
Figure 9. X-star record from along line of ordnance placed for test of system

prospective site clean-up activities. As the first step in testing the X-star, it was towed several times approximately 1 to 2 m above the inert ordnance test bed. Targets were detected which may be interpreted as representing the ordnance located on the bottom (Figure 9); however, nothing could be detected at the location of the single buried piece or at the buried cluster. Since a return from the buried ordnance could not be detected, we conclude that the scattering of the acoustical signal by the sandy sediment prohibits the use of X-star to identify buried ordnance targets in this setting. The X-star was towed along a number of lines in the survey area and throughout the record there were target returns from the bottom surface similar to those observed in the test bed at the Coast Guard Station. There were some subsurface targets noted in the tows from the borrow area, but the nature of these returns could not be used to verify if they were or were not ordnance. The acoustical return from the X-star cannot be used to discriminate between objects of different composition. Thus, the observed returns could be stones, wood, or ordnance. The conclusion of the pilot study is that X-star would be of limited use during the conduct of a full-scale survey.

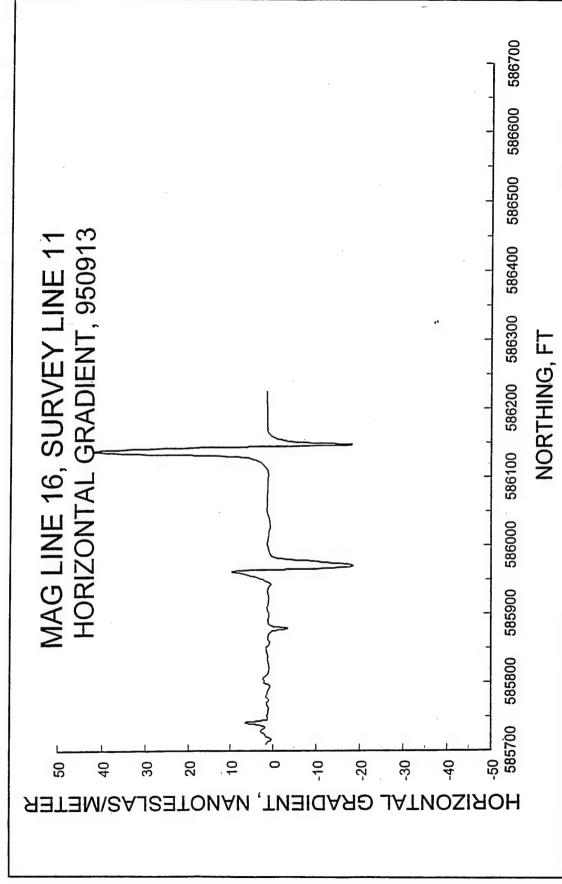
Figure 13. Horizontal magnetic gradient recorded in ordnance disposal area, magnetic line 16 (reference Figure 6)

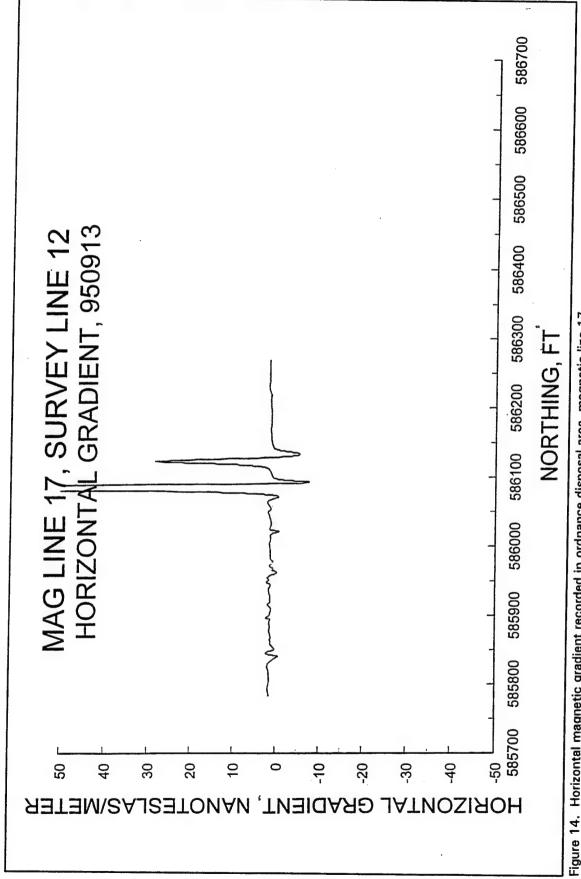
Figure 14. Horizontal magnetic gradient recorded in ordnance disposal area, magnetic line 17

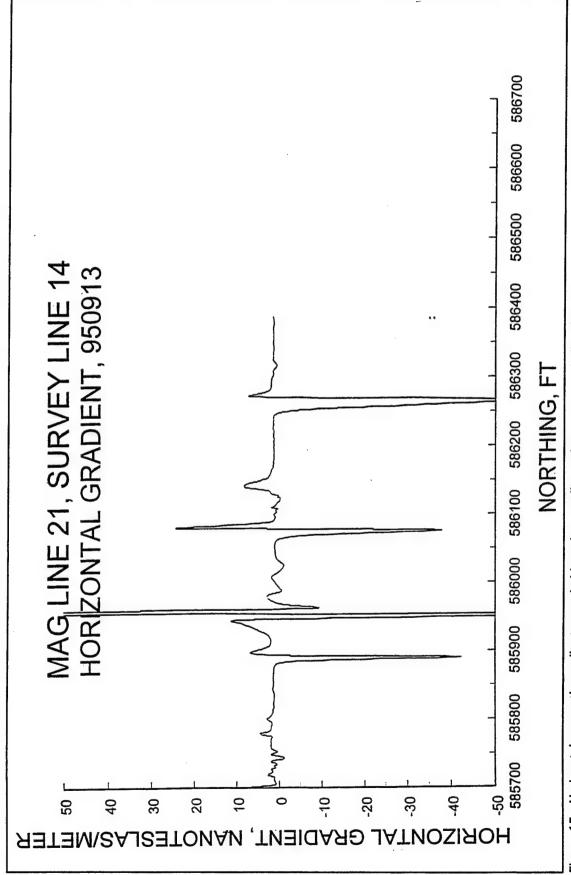
Figure 15. Horizontal magnetic gradient recorded in ordnance disposal area, magnetic line 21

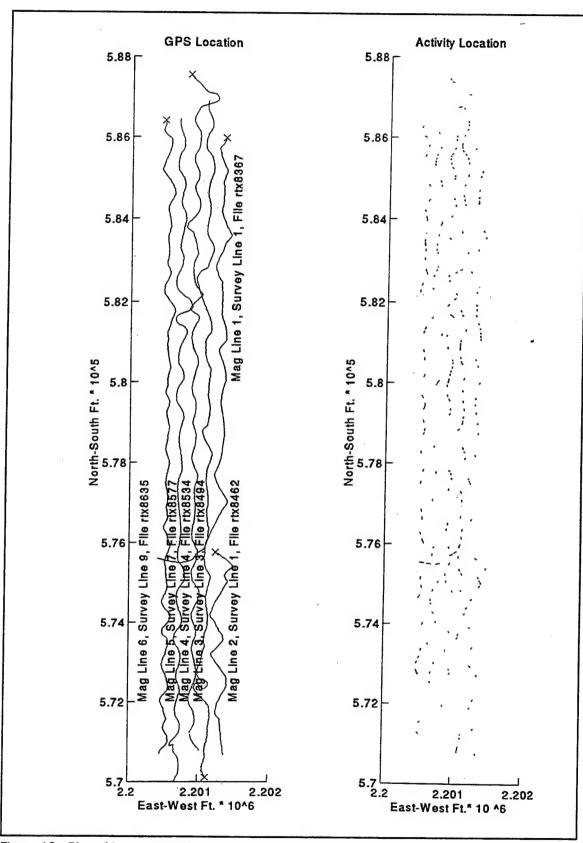
borrow area. Magnetic signatures obtained during the pilot study indicated the presence of numerous dipole objects corresponding to ordnance signatures in the areas surveyed. The occurrence of these characteristic signatures diminished toward the south. The most common detected dipole objects were:

(a) comparable in size to 6- to 12-in. shells, (b) located at or near the sand surface, and (c) oriented generally parallel to the shoreline (north-south). This information has implications concerning the mobility of the ordnance and methods to be used in any potential site cleanup operations. Other specific magnetic signatures have been identified as representing metal spheres (such as a cannon-ball), marine clutter (such as a zone of odd-shaped metal fragments), and larger objects (drums and possibly shipboard jetsum). Further post-processing of the magnetic data would give additional information concerning individual objects and the orientation, approximate size, and three-dimensional location of these defined targets.

Figure 18. Plot of long magnetic traverses showing truck lines on left and zones of magnetic response on the right. Scales are in feet measured from arbitrary zero points - locations do <u>not</u> represent State Plane coordinates

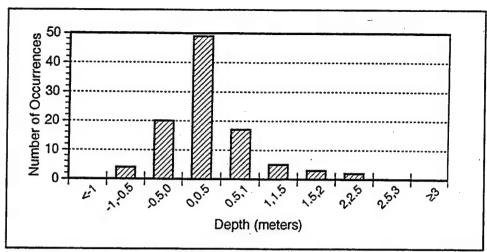
The distribution in depth for the test anomalies is shown in Figure 30. Most objects were lying on the seafloor, but a small minority appeared to be hovering 50 to 100 cm above the bottom. It is not clear if these peculiar results were due to faults with the altitude sensor, raised seafloor areas, or some other undetected problems. Possibly they represent long or irregular-shaped marine debris that are

Figure 30. Computed depth from seafloor to center of objects. Negative values correspond to dipole fits where the center of object is above the bottom. Most objects are lying on the seafloor. (Plot provided by AETC)

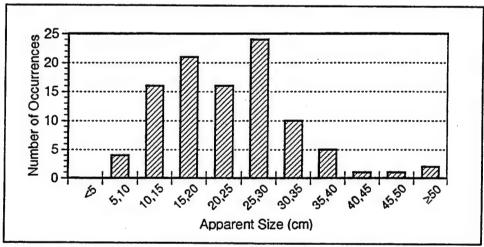
Finally, Figure 31 shows the distribution of apparent sizes of the anomalies. The apparent size of an object is its equivalent radius, which is the radius of a steel ball having the same dipole moment. Bell, DeProspo, and Prouty (1996) found that ordnance caliber is almost equal to the measured dipole radius. Figure 31 also shows that objects range from 5 to 50 cm, with the most common clustering between 10 and 35 cm (4 to 14 in.). These sizes are consistent with the caliber of ordnance recovered in the test raking operation by the *Miss Kathy*, but the distribution is different. The distribution of the raked ordnance was dominated by smaller pieces (*i.e.*, 8- to 13-cm range), and the raking operation only recovered 24 objects, a sample size too small to use to evaluate the distribution of size classes (Figure 32).

Figure 31. Distribution of apparent sizes of the 100 test objects. (Plot provided by AETC)

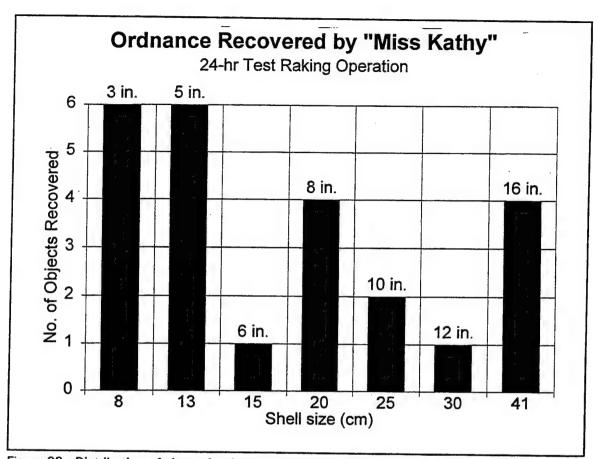
Figure 32. Distribution of sizes of ordnance recovered during 24-hr test raking operation
